Manhole Inspection Summary

Manhole # S15II_003MH

Insp Date: **3/20/08 2:43 PM**

Location Address: **2525 NORTH AVE**

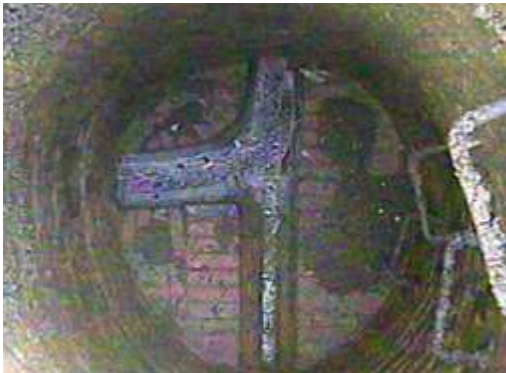
Top View

Cover

Condition: **Worn**

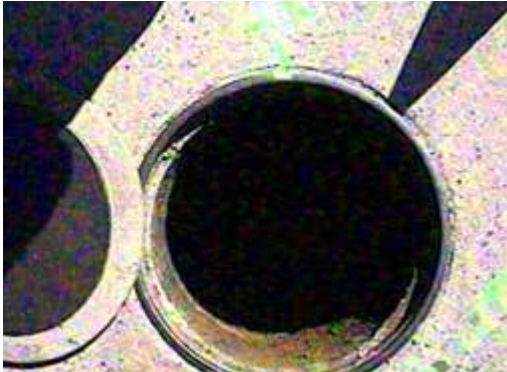
Top View

Offset: **1** (in.)

FRAME OFFSET

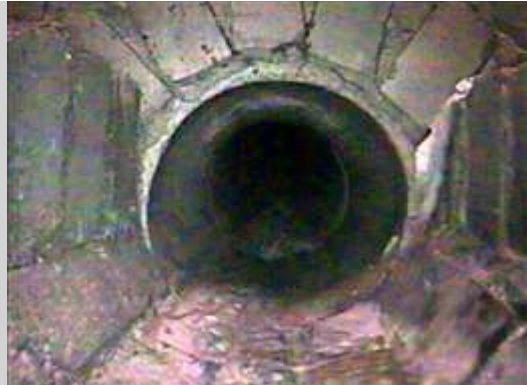
12 O'Clock Outflow

8 in. Circular Gravity Sewer
Pipe Out @ 12 O'Clock

Pipe Height: (in.) Direct
Pipe Material: **Clay** ☐ Pipe Lined
Invert Depth: **8.97** (ft.) Flow Characteristics: **Fast**
Deposits: ☒ None ☐ Mud ☐ Sludge ☐ Debris ☐ Grease
Silt Depth: (in.) Deposits Extent:
Infiltration: **None** Pipe Seal Cond: **Sound**

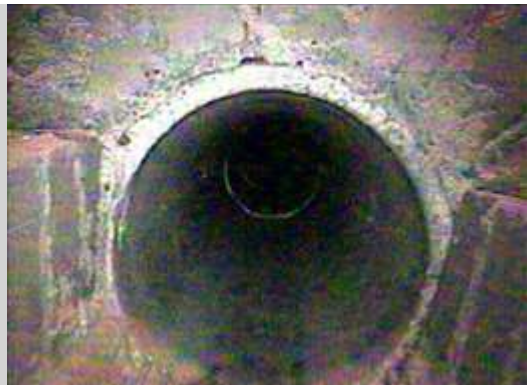
6 O'Clock Inflow

8 in. Circular Gravity Sewer
Pipe In @ 6 O'Clock

Pipe Height: (in.) Direct
Pipe Material: **Clay** ☐ Pipe Lined
Invert Depth: **8.12** (ft.) Flow Characteristics: **None**
Deposits: ☒ None ☐ Mud ☐ Sludge ☐ Debris ☐ Grease
Silt Depth: (in.) Deposits Extent:
Infiltration: **None** Pipe Seal Cond: **Sound**

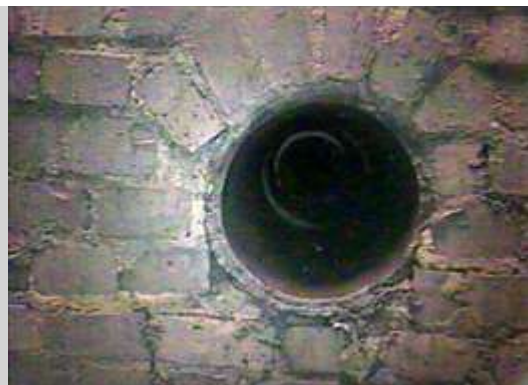
9 O'Clock Inflow

8 in. Circular Gravity Sewer

Pipe In @ 9 O'Clock

Invert Depth: **5.68** (ft.) Flow Characteristics: **Fast**

Infiltration: **None** Pipe Seal Cond: **Sound**

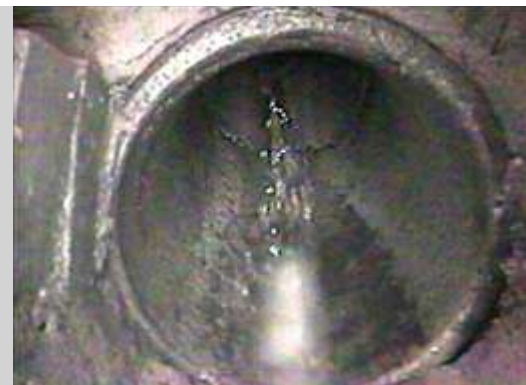
Drop In @ 9 O'Clock

Drop: **Outside Direct**

Inv Depth: **8.27** (ft.)

Drop Condition: **Open**
